# Manhole Inspection Summary

Manhole # S53C\_\_037MH

**Inspection** ☐ Is Incomplete Rating: **5) Immediate Attention Required**

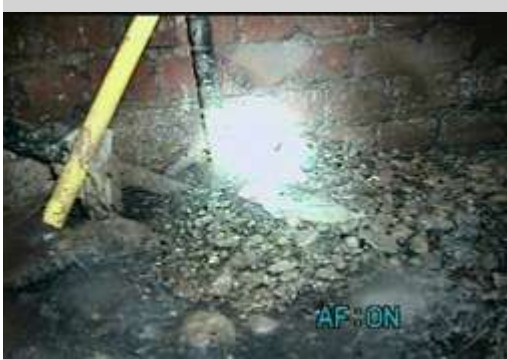
Defect 3

Condition: ☐ Sound ☐ Cracked ☐ Root Intrusion ☐ Deteriorated ☐ Leaks ☒ **Debris**

bench debris

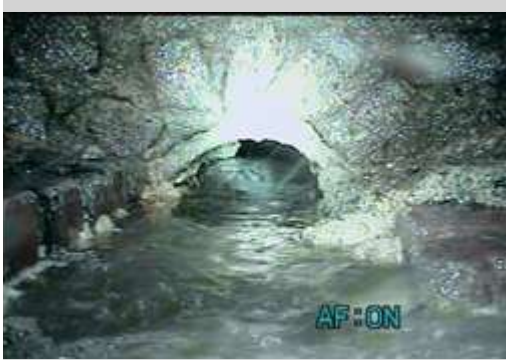
Defect 4

Infiltration: ☐ None ☐ Joint ☐ Cracks ☐ Mortar ☐ Roots ☒ **Wall**

Condition: ☐ Sound ☐ Cracked ☐ Root Intrusion ☐ Deteriorated ☐ Leaks ☒ **Debris**

channel debris, Barrel Infiltration

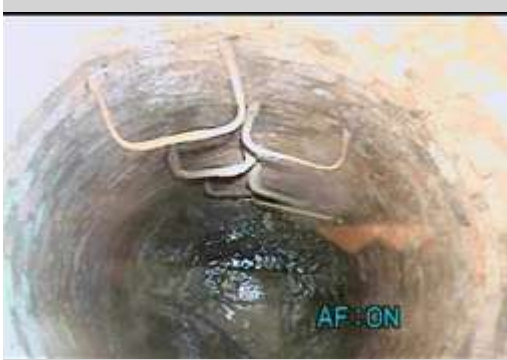
Defect 2

Count: **6** Missing: **0** ☒ **Corroded**

steps

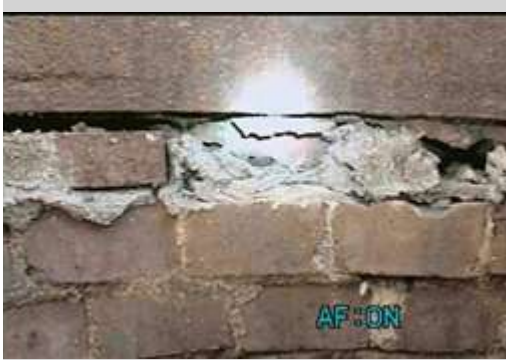
Defect 1

Condition: ☐ Sound ☐ Cracked ☐ Root Intrusion ☒ **Loose Brick** ☒ **Deteriorated**

chimney loose bricks,deteriorated, frame adj

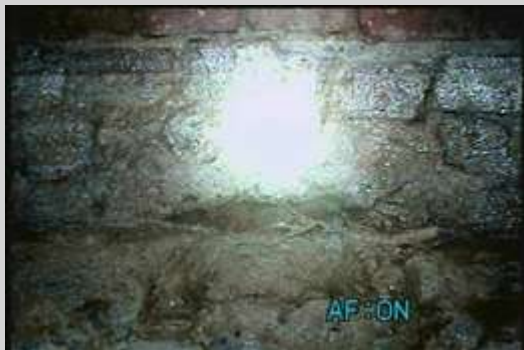
12 O'Clock Outflow

pipe is almost completely block has little flow outward

Deposits: ☐ None ☐ Mud ☒ **Gravy** ☒ **Debris** ☐ Grease

Silt Depth: 7.5 (in.) Deposits Extent: **Heavy**

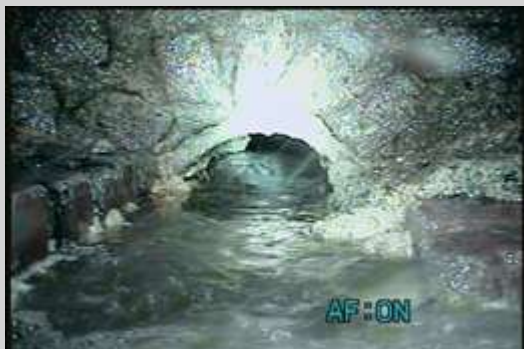
6 O'Clock Inflow

Deposits: ☐ None ☐ Mud ☒ **Gravy** ☒ **Debris** ☐ Grease

Silt Depth: 4 (in.) Deposits Extent: **Medium**

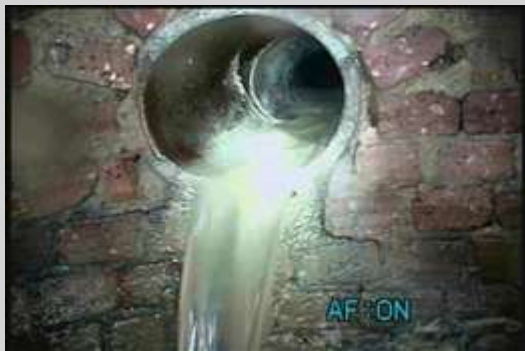
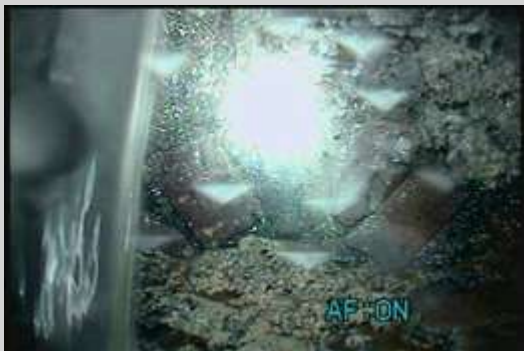
9 O'Clock Inflow

pipe is almost completely blocked but it still has flow

Pipe Height: 0 (in.) Direct  
Pipe Material: Clay ☐ Pipe Lined  
Invert Depth: 9.91 (ft.) Flow Characteristics: Fast  
Deposits: ☐ None ☐ Mud ☒ Sludge ☐ Debris ☐ Grease  
Silt Depth: 7.5 (in.) Deposits Extent: Heavy  
Infiltration: None Pipe Seal Cond: Unknown
